## Catholic Diocese of Bathurst

### **Stage 1 of the Restoration of the Cathedral of St. Michael and St. John to be completed in early December**

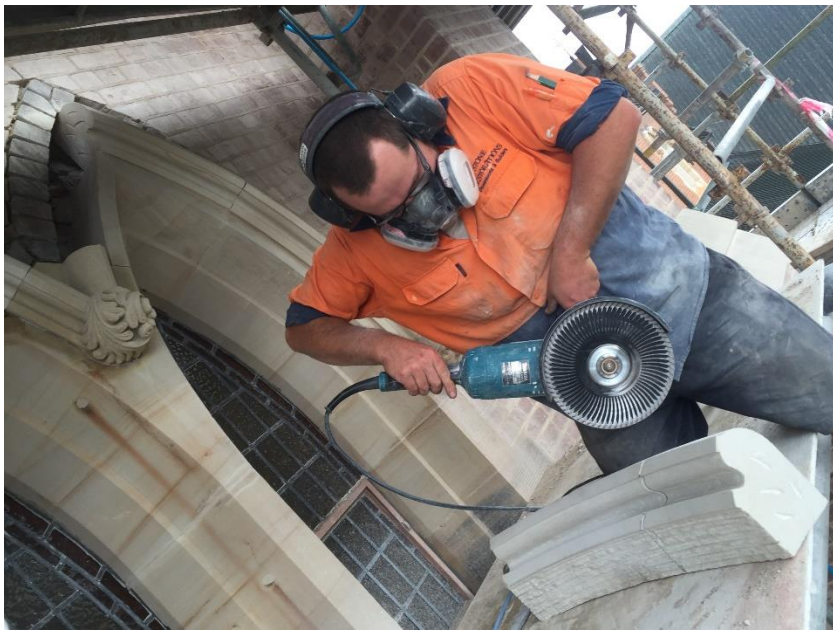
*Stone Mason, Tye Murphy from Stone Restorations making the finishing touches to the final piece of stone to be replaced*

This week, the finishing touches will be made to the brickwork and jointing around the replaced sand stone and cleaning of the walls will commence. After cleaning the top of the bell tower, the top section of scaffold will come down, followed by installation of louvres and mesh screens. Installation of the newly refurbished bells will occur in the first week of December.

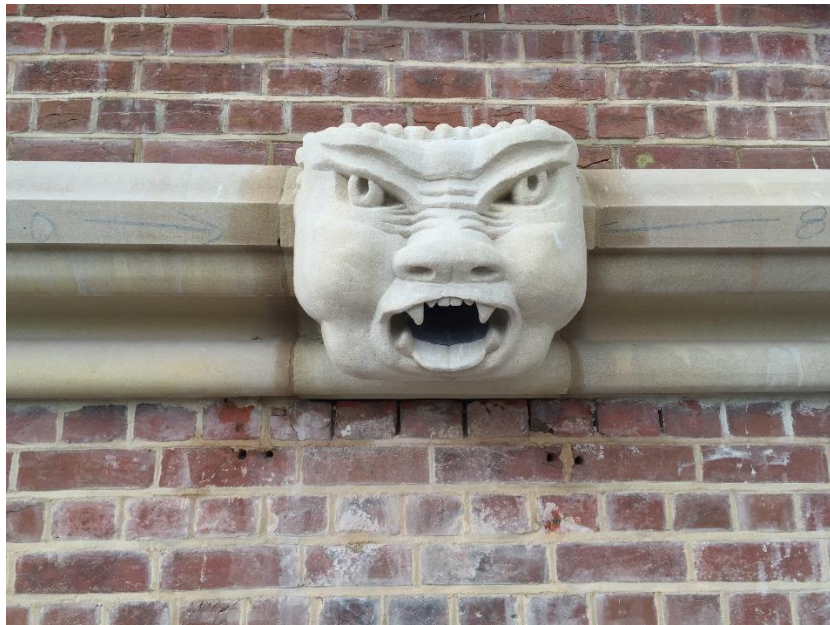
The final stones were replaced in the bell tower late last week, one being the gargoyle, as pictured.

*The newly restored gargoyle*

More than 100 pieces of sandstone were removed and replaced with replicas of the original stones, which includes extremely ornate scrolls, roses and the original gargoyle, taking many hours of hand carving and shaping.

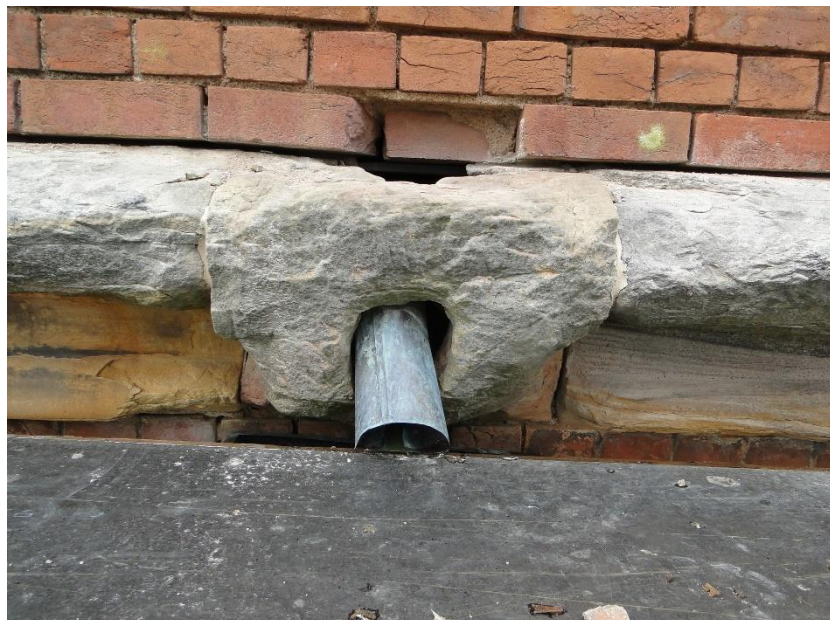
“The Cathedral is an extraordinary and quite rare piece of architecture, not often seen outside metropolitan areas. It was extremely deteriorated after more than 150 years of exposure to the elements, with severe salt and water damage. Working 23 meters above the ground through two Bathurst winters also created difficulties”.

*The gargoyle prior to restoration*
